Helgö, from postholes to houses

**An archaeological building analysis of Terraces I and III in
Building Group 2 at Helgö**

Per Frölund and Hans Göthberg

Upplandsmuseets rapporter 2017:06
ISSN 1654-8280

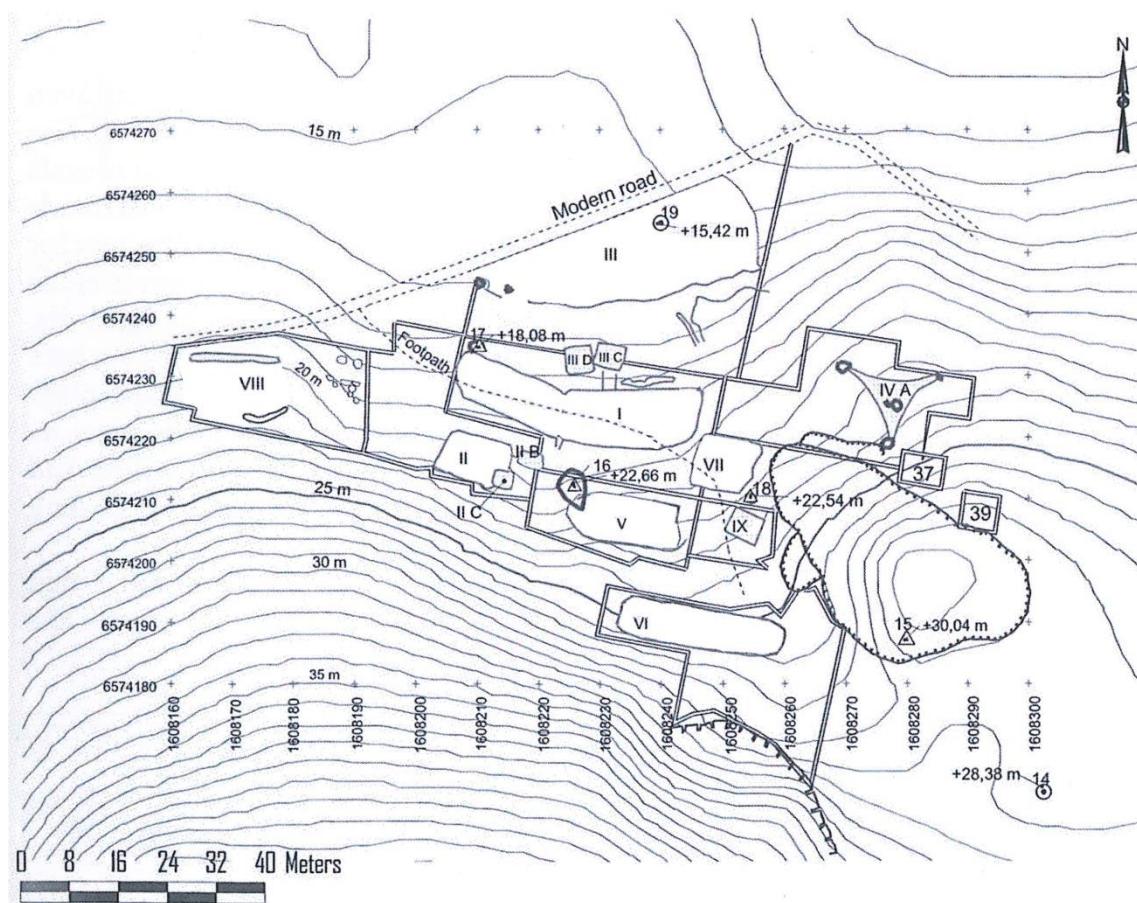
Figure 1. The terraces in Building Group 2 at Helgö lay on a north-facing slope, between 30m and 15m a.s.l. (Kitzler Åhfeldt 2008, fig. 4, slightly modified)

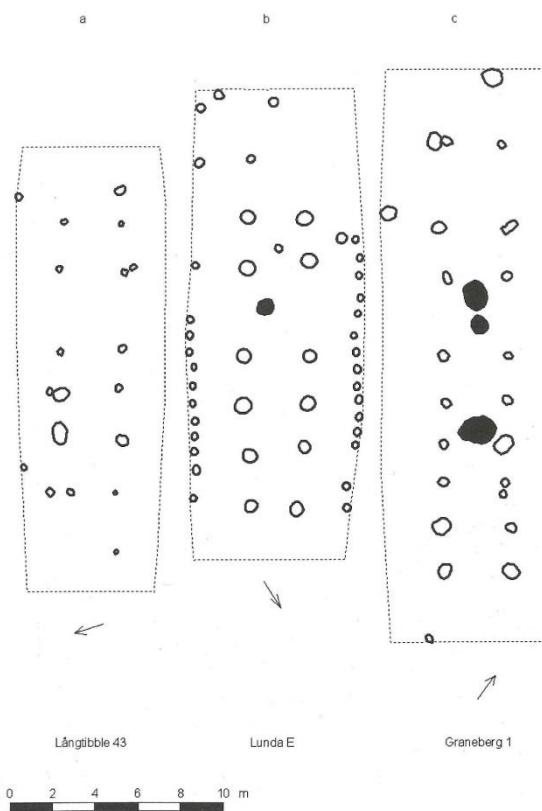
The central aisle (or nave), defined by longitudinal rows of paired posts, was about (or slightly less than) half the total width of house. Mainly found in Pre-Roman and Early Roman Iron Age (5th century BC—2nd century AD) and are much less common in Late Roman Iron Age (late 2nd century AD—4th century AD) See Göthberg 2000, p91; Wikborg & Onsten-Molander 2007, p114–115).

Figure 3. Examples of houses with balanced construction (Göthberg 2000, fig. 9).

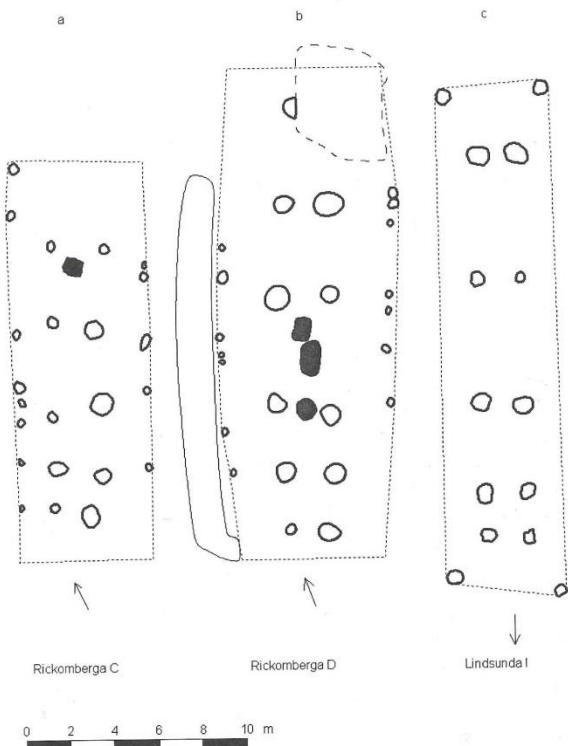
Underbalanced construction (*underbalanserad konstruktion*): used of plans of three-aisled halls. The central aisle (or nave), defined by longitudinal rows of paired posts, was about on third of the total width of house. This type first appears sporadically in the Early Roman Iron Age (1st or 2nd century AD), becoming more prevalent from the Late Roman Iron Age (late 2nd century AD onwards).

Figure 4. Examples of houses with underbalanced construction (Göthberg 2000, fig. 21).

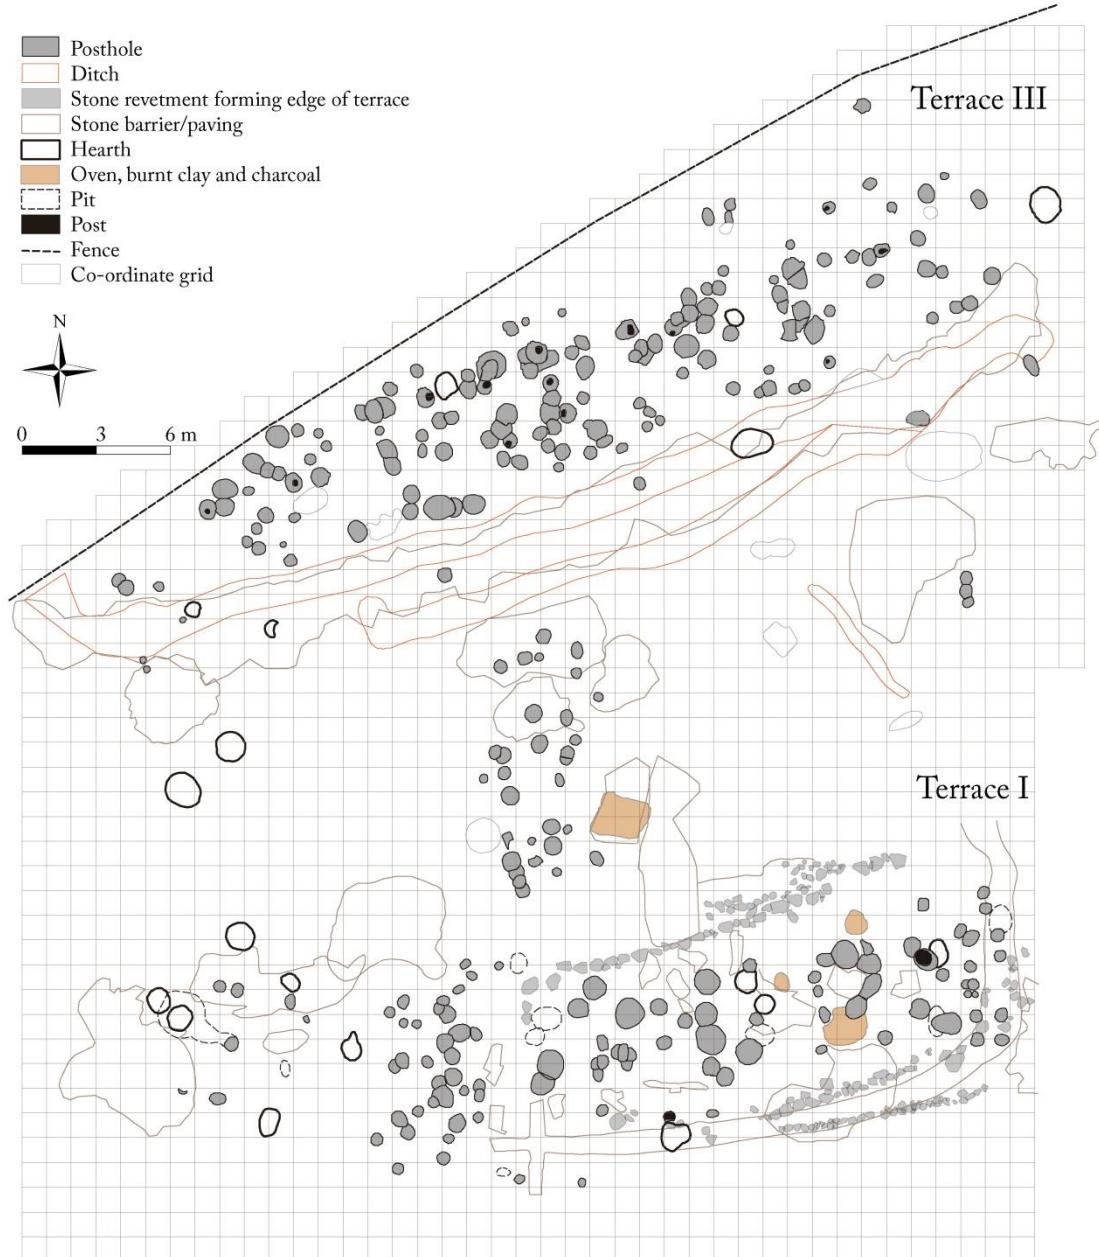
Figure 5. Outline plan of the features on Terraces I, III and the area between them. The only stones included here are those which made up part of a structure. The features are set against the Helgö Project's co-ordinates.

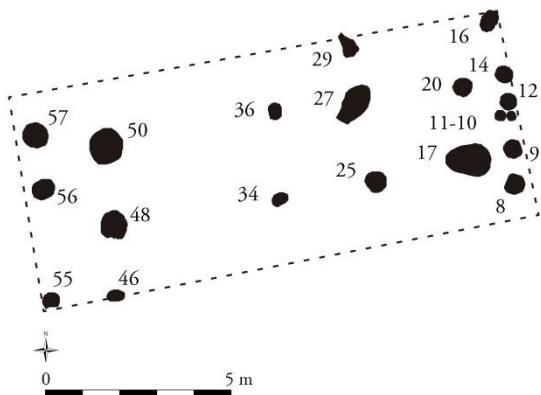
Figure 7. House 1, scale 1:200.

Constructional details consisted of 8 roof-supporting posts and 13 wall and gable posts. Dimensions **13.5 x 5.6m**. Interior structure of 8 posts in 4 pairs. Underbalanced, three-aisled and divided into two areas.

House 1 was contemporary with ditch and was older than Houses 2 and 4.

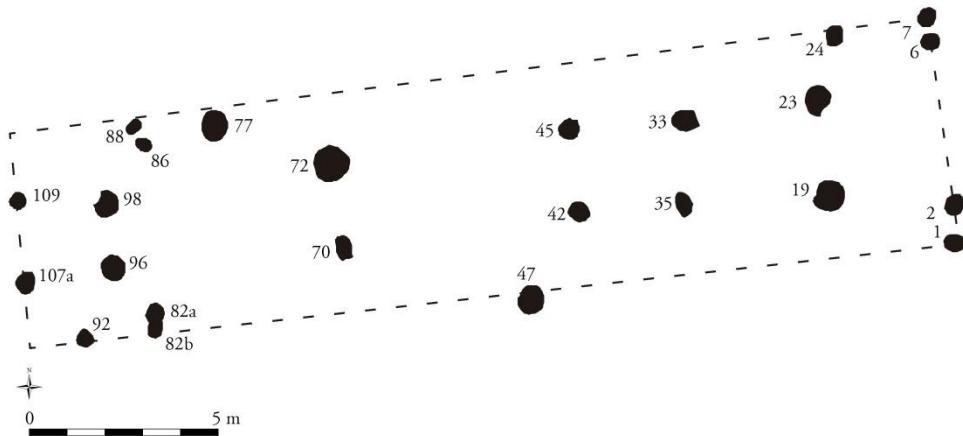
Figure 8. House 2, scale 1:200.

Constructional details consisted of 10 roof-supporting posts and 7 wall and gable posts. Dimensions **25 x c.6m**. Internal structure of 10 posts in 5 pairs. Underbalanced, three-aisled and divided into two areas.

House 2 was later than House 1 and older than House 4.

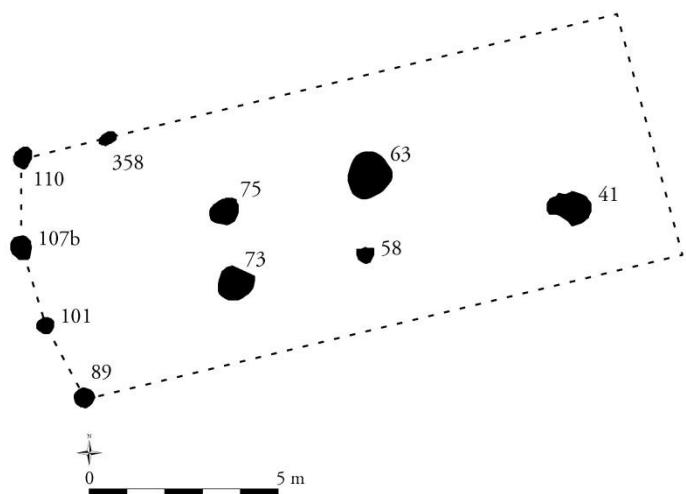
Figure 9. House 3, scale 1:200.

Constructional details consisted of 5 roof-supporting posts and 5 wall and gable posts. Dimensions **<15 x 6.54m**. Interior structure of at least 7 posts in 4 pairs. The missing post-hole possibly damaged by hearth A44. Underbalanced and three-aisled, single room.

House 3 was older than House 4 and possibly later than House 2.

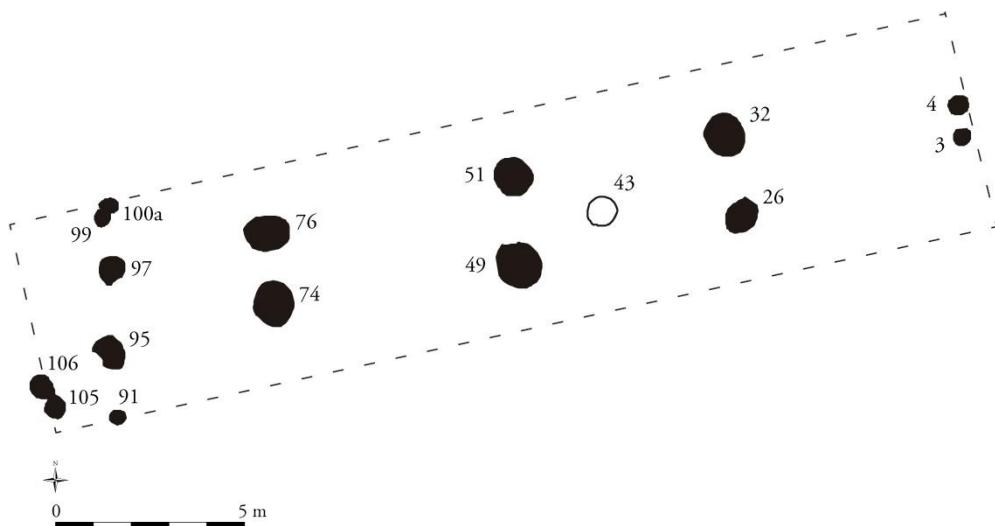
Figure 10. House 4, scale 1:200.

Constructional details consisted of 8 roof-supporting posts and 7 wall and gable posts. Dimensions **25 x 5.7m**. Inner construction of 8 posts in 4 pairs. Underbalanced and three-aisled, single room.

House 4 was later than Houses 1, 2, & 3.

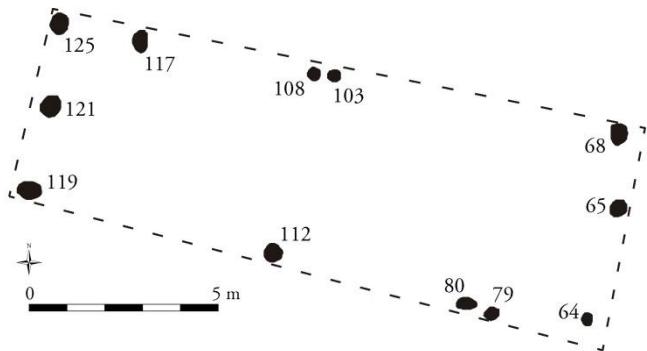
Figure 11. House 5, scale 1:200.

Constructional details consisted of 12 wall and gable posts. Dimensions **15 x 5m**. Roof carried by 12 posts, 3 in each gable and 3 in long walls. Some posts may be missing.

House 5 was earlier than/contemporary with stone paving A20174.

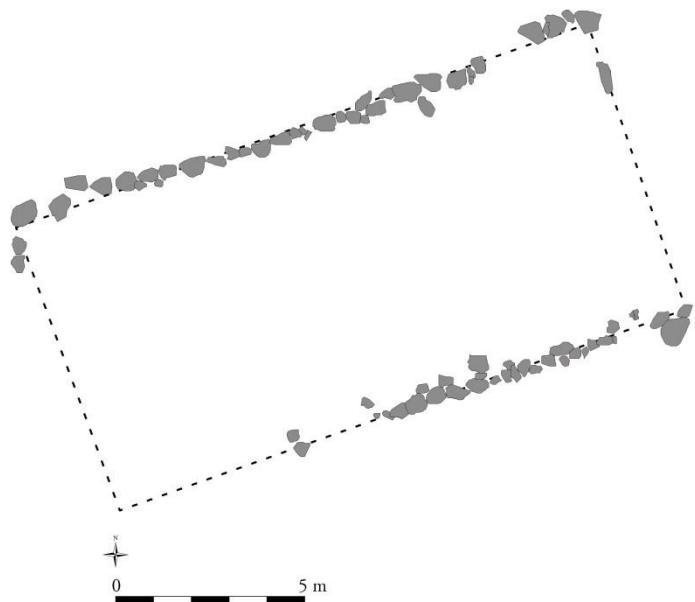
Figure 12. House 6, scale 1:200.

N and S sides of House 6 were part of stone edging of Terrace I, and a few stones in E and W short sides suggest walls connected them. The N & S stone edgings parallel and 7.5m apart, 16.4m long on N side. On S side it is 8.5m, possibly 11m if an isolated stone in the ditch is included.

The structure cannot have been contemporary with House 5 as the two houses overlapped.

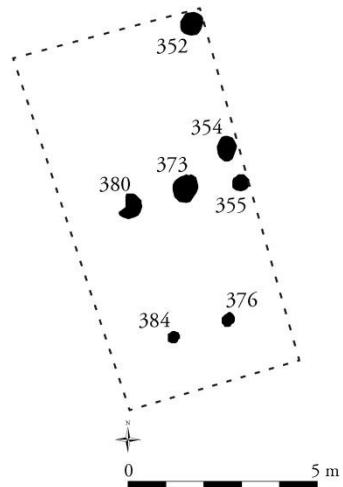
Figure 13. House 7, scale 1:200.

Constructional details consisted of 4 internal post-holes and 3 for long wall and gable. Dimensions **c.8m x 4.5m**. Internal roof-supporting posts in two pairs, 1.5m apart. Total span 3.6m. Underbalanced. N pair post-holes rather shallow, 4 with stone lining.

House 7 was earlier than House 8.

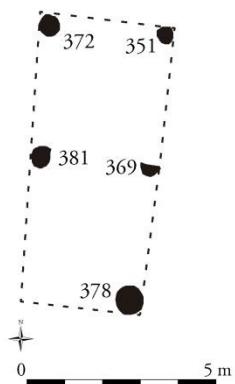
Figure 14. House 8, scale 1:200.

Roof carried on wall posts, 5 post-holes remaining, 1 destroyed by pit A390. Dimensions **7m x 3m**. Rectangular house with corner posts, type D5. All post-holes except that in NW were fairly large, and all except NW one were lined with stones.

House 8 was later than House 7.

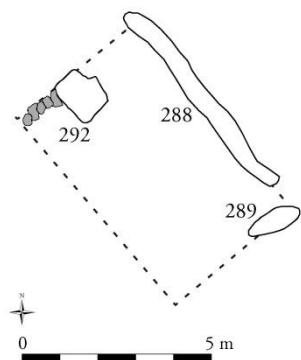
Figure 16. House 10, scale 1:200.

Structure consisted of a few disparate parts. Overall dimensions **6m x 3.5m**. Clearest feature was ditch A288 in NE, **5.9m** long, may have been eavesdrip or drain as it was rather sinuous. Also, stone row in NW, **1.5m** long, possibly a short sill. Pit A292 with charcoal in bottom was remains of hearth, lying next to N wall.

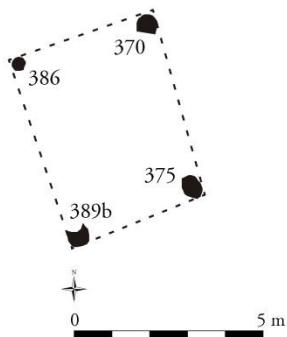
Figure 17. House 11, scale 1:200.

Constructional details consisted of post-holes for 4 roof-supporting corner posts, **4.8 x 3.2–3.5m** rectangle. All post-holes were stone-lined. The 2 southern post-holes lay in dug-away part of slope and were covered with layer of red clay.

House 11 was older than House 7, as the layer of red clay covered postholes in House 11, and was older than postholes from House 7 and 8.

The features in this area included a group of post-holes from which at least three houses could be reconstructed. House 11, with four corner-posts belonged to the group of earliest buildings on the site, as its southern post-holes were covered by a layer of red clay and were cut by other post-holes. It was probably replaced by the three-aisled House 7 which had the same orientation. More post-holes were found in the area of the two houses, following their west walls and in some cases reflecting their orientation through being rectangular or oval in plan. They could have been the result of rebuilding, or may indicate the presence of earlier buildings.

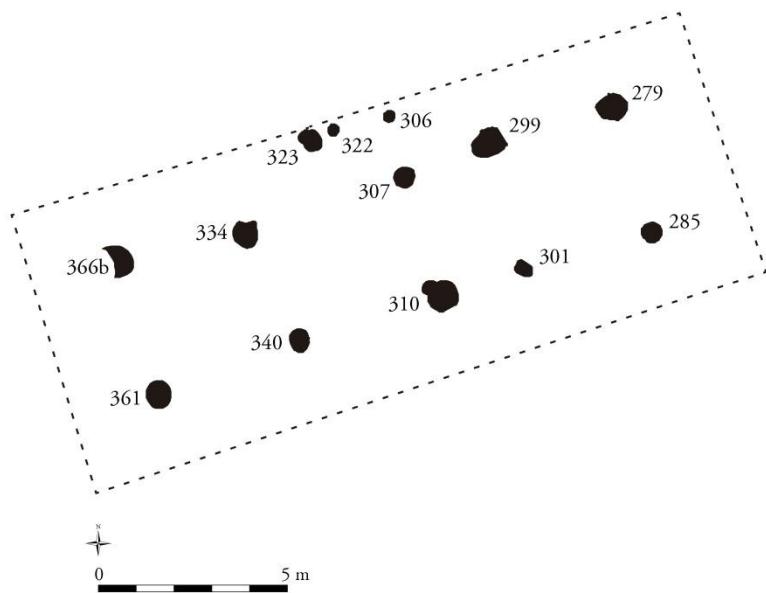
Figure 18. House 12, scale 1:200.

Constructional details consisted of 10 roof-supporting post-holes & 3 in N wall. Total length of house **c.18m x c.7m**. 10 post-holes in 5 pairs **3.2–3.6m** wide. Longitudinal distance between post-holes **2.3–4m**. All but 2 post-holes were stone-lined. Balanced, three-aisled, type A1.

House 12 was older than House 16.

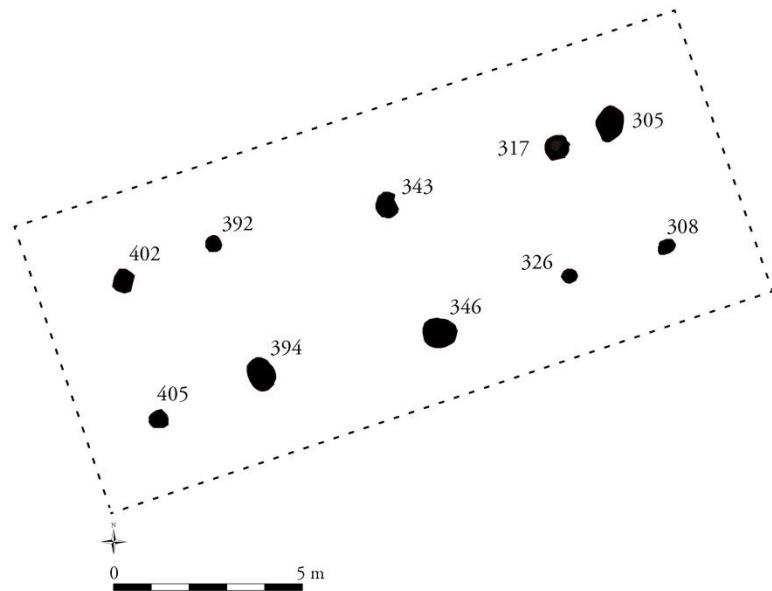
Figure 19. House 13, scale 1:200.

Constructional details consisted of 10 post-holes in 5 pairs, one post-hole extremely small. Total length of house **c.18m x c.7m**. Probably balanced, three-aisled, type A3 (Göthberg 2000, p39). Width of paired post-holes **3.6 – 3.7m**, longitudinal distance between them **1.5 – 4.7m**. 5 post-holes were stone-lined.

The house was older than Houses 16, 17 and 18.

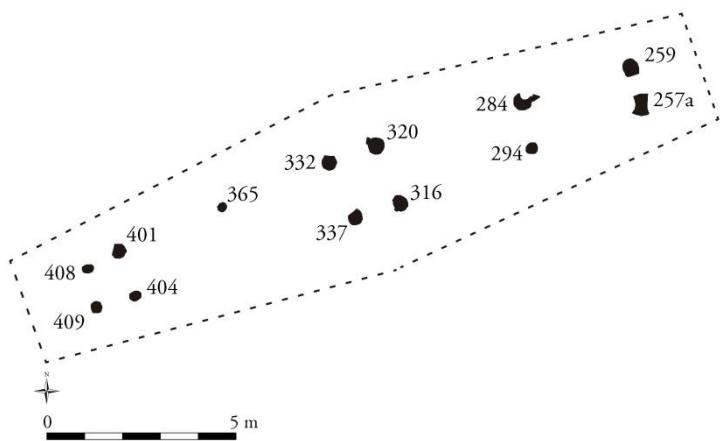
Figure 20. House 14, scale 1:250.

Constructional details consisted of 13 post-holes for roof-supporting posts, in 6 pairs plus one single. Width of pairs **1.5–2.5m**. No sign of walls or gables. Total length of house **28m**. Probably convex in plan, up to **7.5m** wide. Three-aisled, underbalanced, type B3 (Göthberg 2000, p62–79). In centre of house 2 pairs of post-holes close together, cf. House 16. Immediately east of them was area with longest longitudinal distance, also cf. House 16, but it differs in being ended in west end by another area with 2 pairs post-holes close together. Post-holes were considerably bigger and deeper in the central and eastern parts, smaller and shallower in west. This may be the reason why one pair was incomplete. Most of the post-holes were stone-lined, particularly in the central and eastern parts. A quern stone was found in one post-hole in the centre.

House 14 was later than House 17.

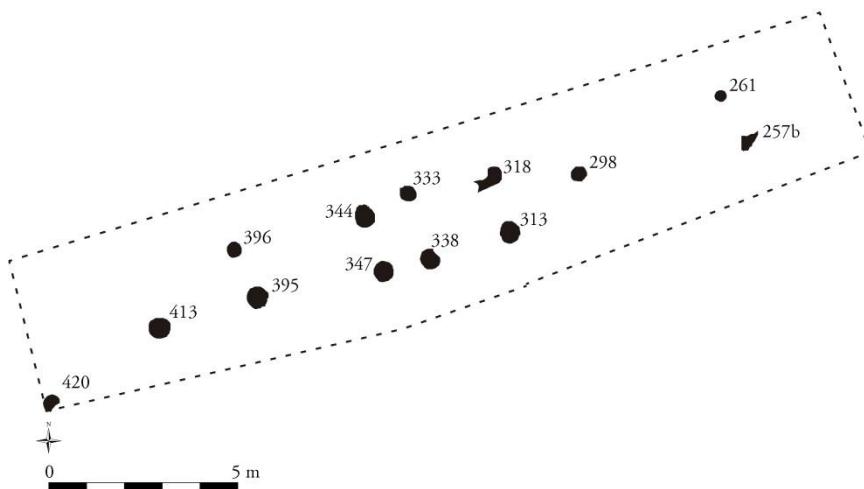
Figure 21. House 15, scale 1:250.

Constructional details consisted of 12 internal post-holes and one in gable. Total length **c.35m**, width **c.7m**. 11 posts in 6 pairs and a single central post. Underbalanced. Width between posts **2.1-2.6m**, somewhat wider in central part, suggesting a slightly convex shape. Longitudinal distance **2-10m**, longest being in eastern part. Like House 17, there was a central post in the longest longitudinal span in east. Possible gable post at west end. All but two internal post-holes were large and stone-lined.

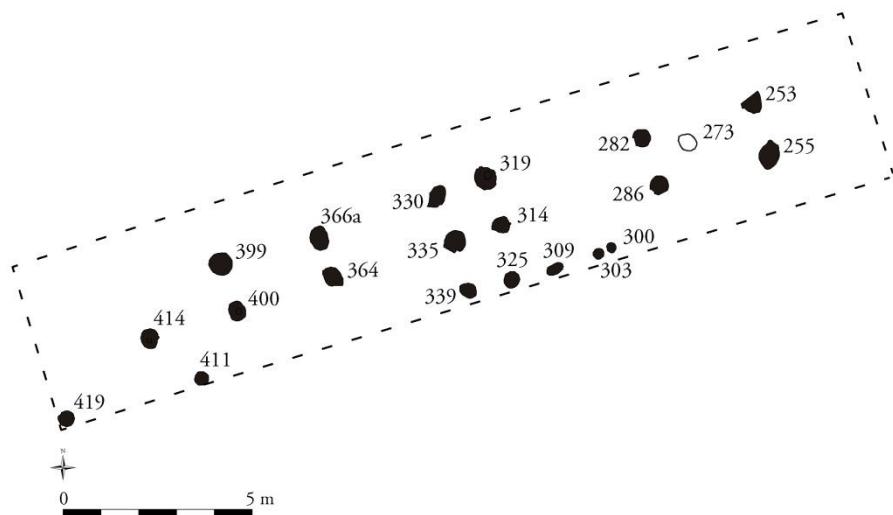
Figure 22. House 16, scale 1:250.

Constructional details consisted of 15 post-holes for roof-supporting posts and 7 for wall- and gable-posts. Probable length of house **34m**, width **6.0–6.5m**. 7 pairs of posts in straight line. Three-aisled, underbalanced, type B3 (Göthberg 2000, p62–79). Width of post-pairs **1.8–2.2m**. Longitudinal distance between pairs **2.0–6.5m**. Section with shortest longitudinal distance was in middle of house, longest distance was to east. Possible gable post in west. Hearth in the east may have belonged to this house. The post-holes were substantial and stone-lined, with one exception (A399). Quern stones found in five post-holes.

House 16, A314 = Early Roman Iron Age ($1805\pm70\text{BP}/\text{St-1125}$; see *Excavations III*, fig. 69). As the stratigraphical conditions of the post-hole were complicated, and as its fill contained ‘odd fragments of charcoal’ (*Excavations II*, p28), it is not certain whether the charcoal came from a post-hole in the building or was redeposited. In either case it indicates activity on Terrace. A sample taken from charcoal at the bottom of pit A292 in House 10 gave a ^{14}C date: $1065\pm85\text{ BP}/\text{St-1126}$ (Viking Age; see *Excavations III* fig. 69). As there were very few features in the surroundings, the date probably reflects activity associated with the building.

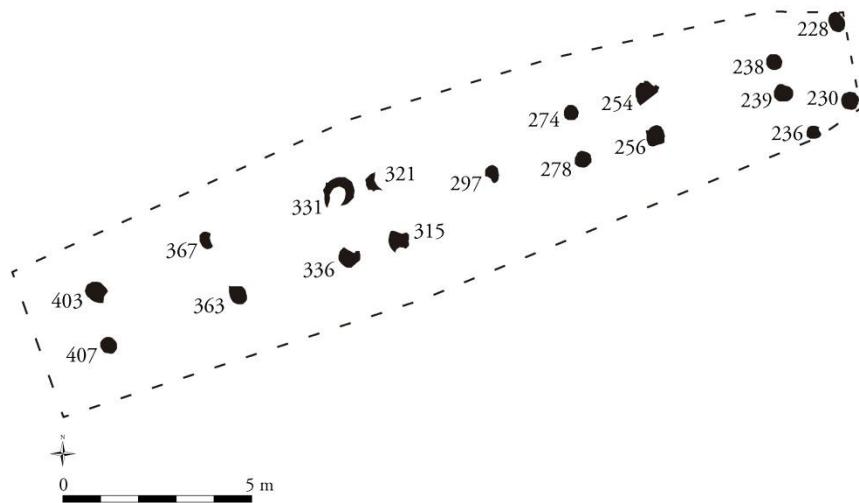
Figure 23. House 17, scale 1:250.

Constructional details consisted of 15 post-holes for roof-supporting posts and 3 for gable and wall. Total length up to **c.35m** and width probably up to **7.5m**. Post-holes in 7 pairs and single post in central axis, all giving a slightly convex shape. Three-aisled, underbalanced, type B3 (Göthberg 2000, p62–79). Width of pairs **1.4–2.6m**, longitudinal distance **2.1–8m**. Shortest longitudinal distance in centre, longest to east, cf. Houses 15 and 16. Central post. East part orientated slightly differently from west. Gable posts in east showing that houses ended at end of North Ditch. All but two post-holes were stone-lined. Quern stones in three post-holes.

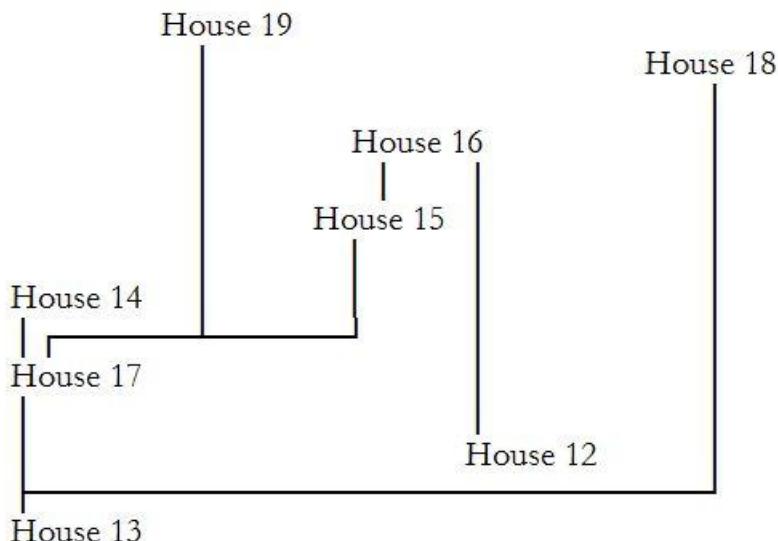
Fig. 29 Stratigraphy of houses on Terrace III

House 13 was a three-aisled house of balanced construction and therefore attributable to the earliest building phase, probably older than the South Ditch as it does not fit into the area defined by it. House 13 was replaced by House 12 which had the same construction and was of similar size but lay within the boundary provided by the South Ditch, with which it was probably connected.

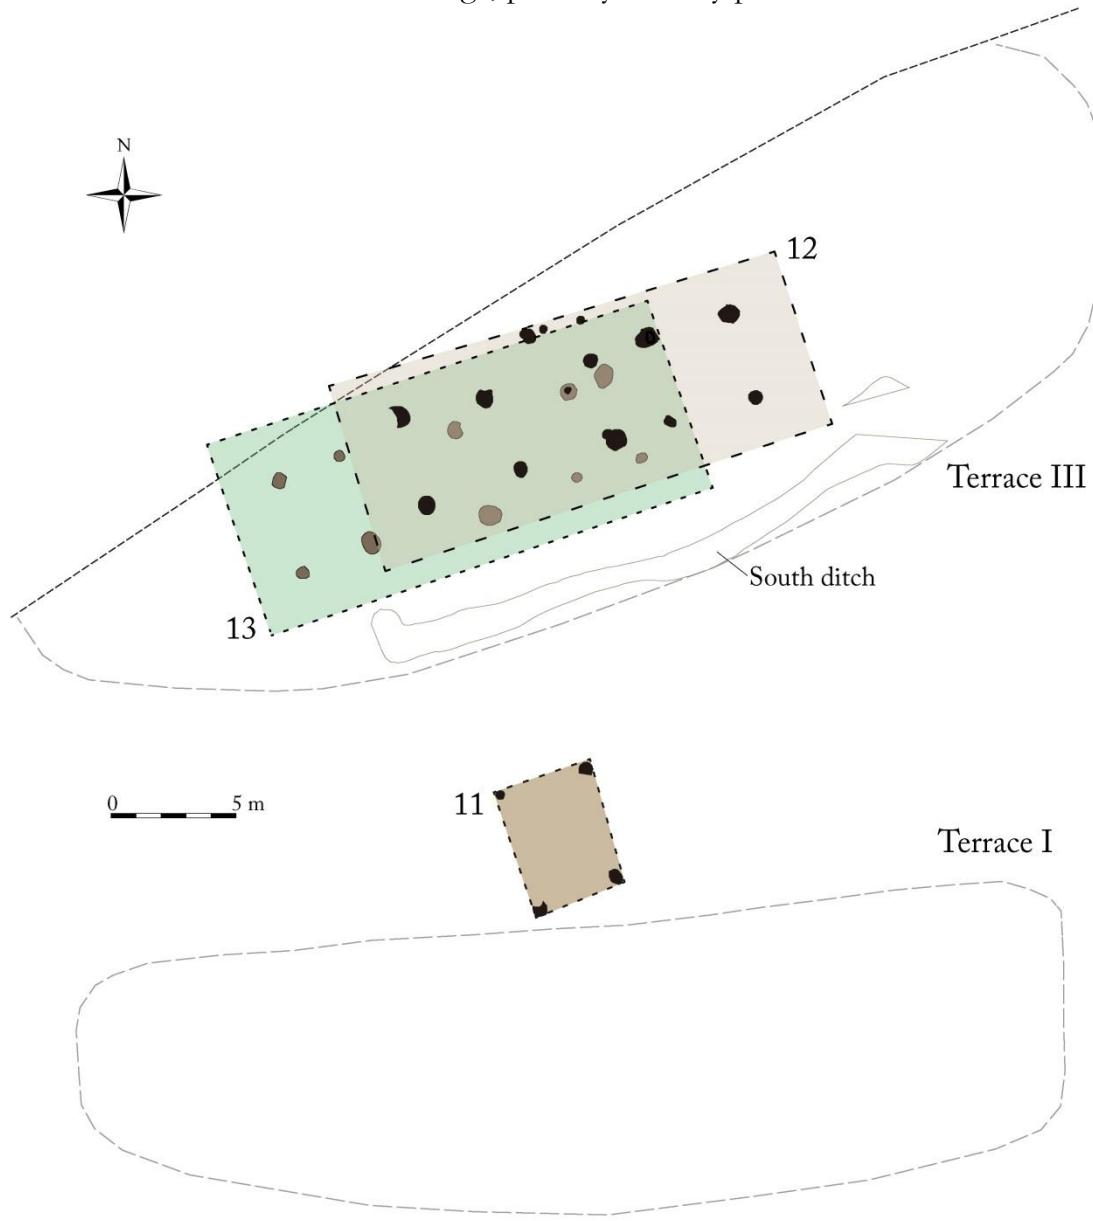
Typology suggests that the earliest settlement consisted of Houses 12 and 13 on Terrace III, and perhaps also House 11 in the intervening area. The occupation can be attributed to the Roman Iron Age, possibly its early part.

Figure 30. The earliest occupation, from the Roman Iron Age, consisted of Houses 12 and 13 on Terrace III, and perhaps also House 11 in the area to the south. The correspondence between House 12 and the South Ditch suggest contemporaneity.

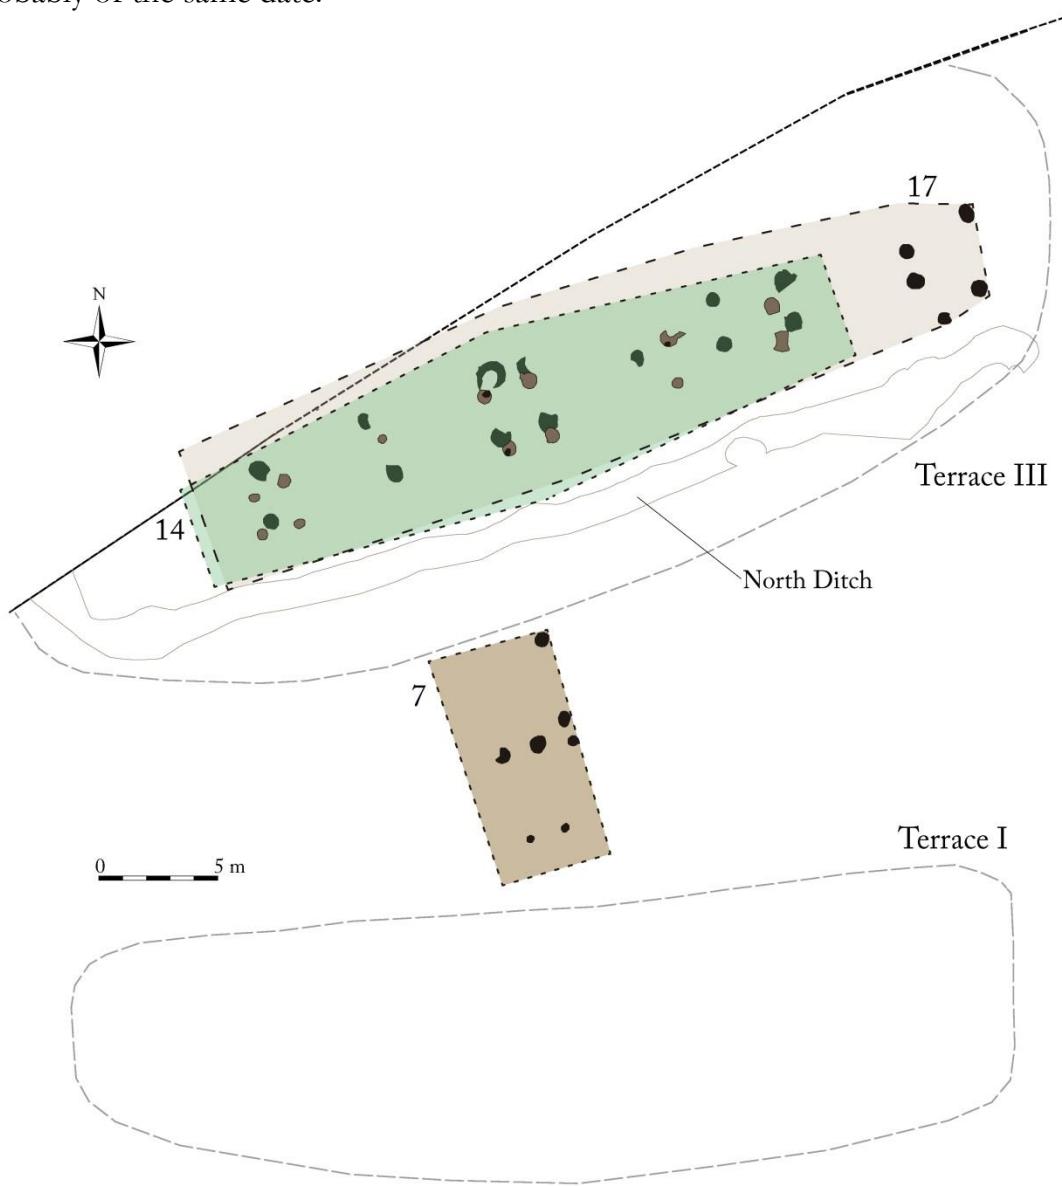
Then followed the sequence of Houses 14–17 on Terrace III with associated Houses 7, 8 and 9 to the south. The large houses date from Late Roman Iron Age/Migration Period, possibly also Vendel Period. The North Ditch and also the stone barrier were probably of the same date.

Figure 31. Late Roman Iron Age/Migration Period occupation is represented by Houses 14 and 17 on Terrace III and probably House 7 on the area to the south. The correspondence between Houses 14 and 17 and the North Ditch suggest contemporaneity.

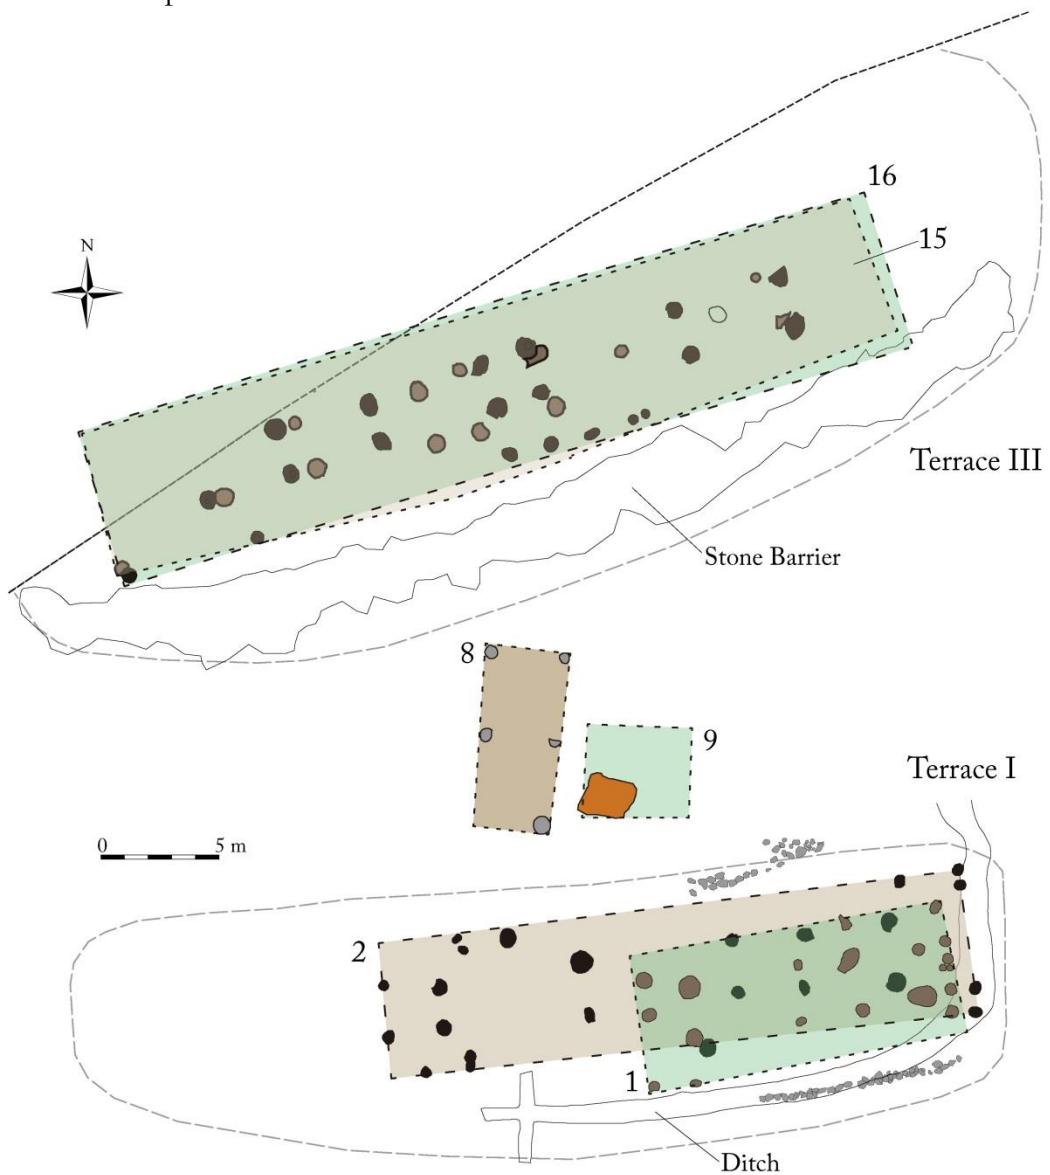
The latest of the large houses (15 and 16) may have been contemporary with Houses 1 and 2 on Terrace I. The gold foils found in post-holes in House 1 suggest that the house was in use during the Vendel Period. The orientation of House 8 and 9 on the intervening area may indicate that they were of the same building phase as the houses on both Terraces I and III. Other things which may have influenced the establishment of the houses on Terrace I is the stone barrier which delimited the south side of Terrace III and must have blocked access between the terraces. There were also light stone pavings around Houses 7 and 8, perhaps part of an attempt to level out the slope.

Figure 32. Houses 1 and 2 on Terrace I, House 15 and 16 on Terrace III and possibly Houses 8 and 9 on the intervening area all date from the Migration to Vendel Periods. The ditch on Terrace I was associated with House 1, and perhaps the stone rows with House 2. On Terrace III a stone barrier replaced the North Ditch.

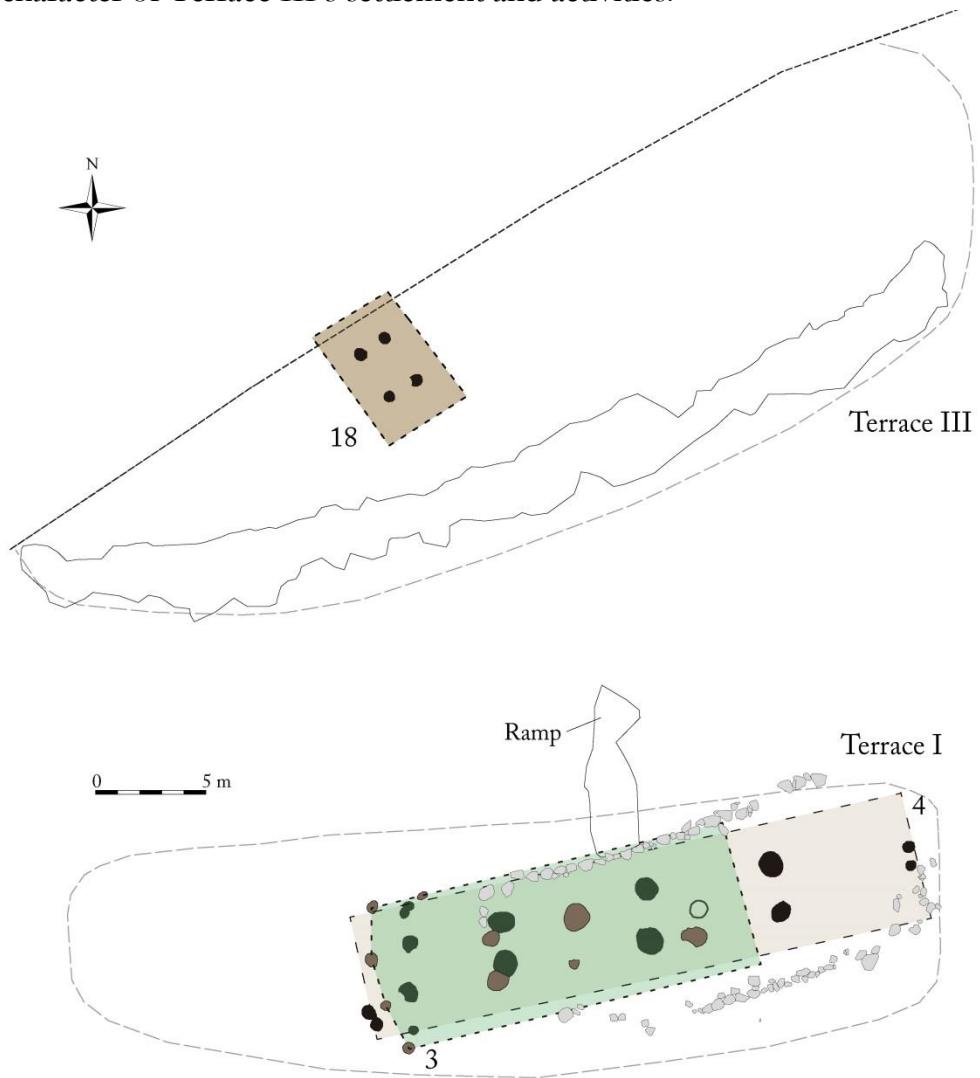
Houses 3 and 4 on Terrace I were probably later than the large houses on Terrace III, but contemporary with House 18. In this phase there was a great change in the extent and character of Terrace III's settlement and activities.

Figure 33. Vendel Period occupation is represented by Houses 3 and 4 on Terrace I and probably House 18 on Terrace III. There was a hearth in House 4.

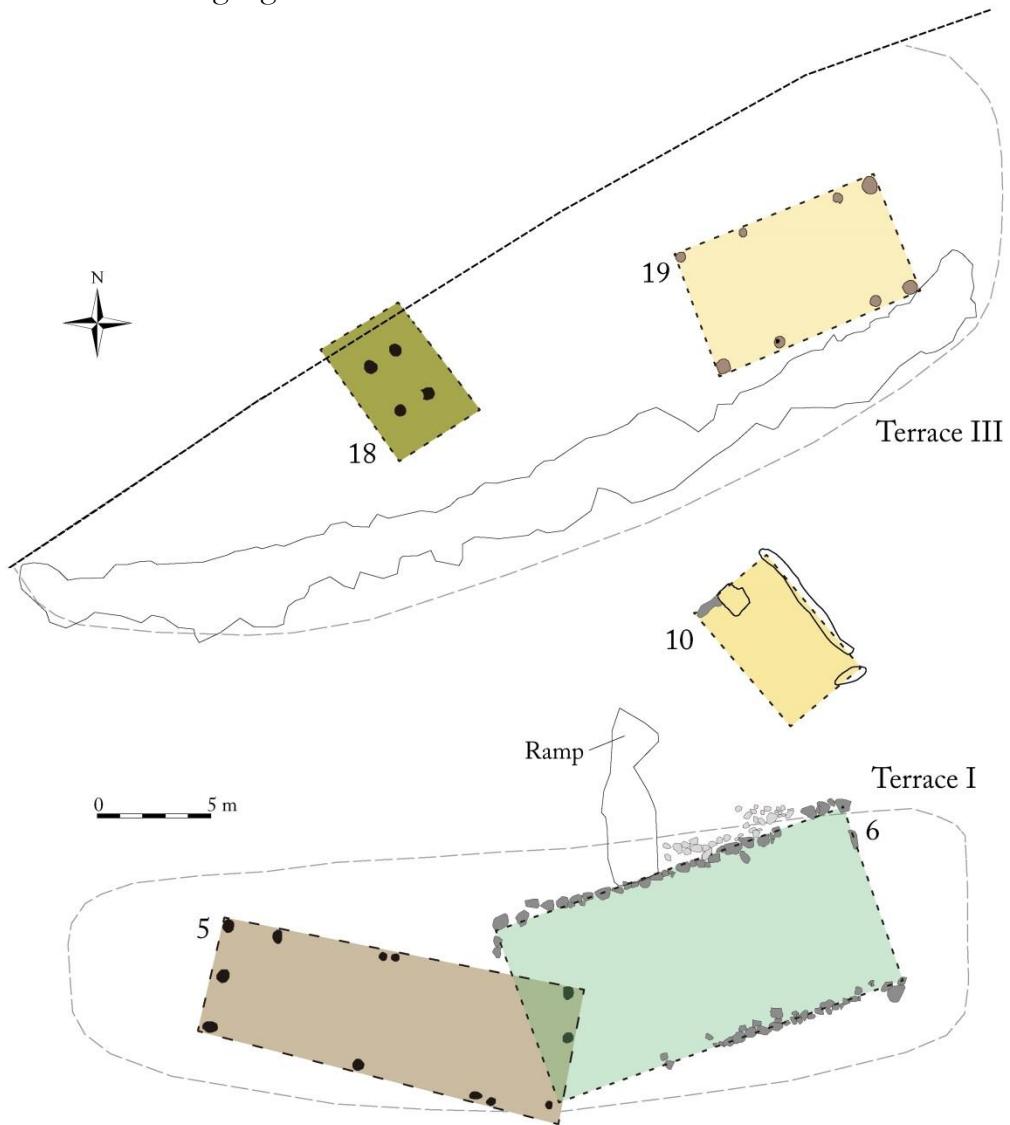
The latest occupation on the two terraces was made up of unaisled houses of varying sizes. House 19 on Terrace III belonged to this phase, and House 18 may have belonged with it, rather than dating from the previous phase. House 5 on Terrace I had a totally different position and orientation from the earlier houses. Some Arabic coins and other Viking Age objects suggest its date. House 6 on the east part of the terrace cannot have been in existence at the same time as House 5. House 10 in the intervening area was probably timber-framed on wooden and stone sills. It was ¹⁴C dated to the Viking Age.

Figure 34. Houses 5 and 6 on Terrace I were probably of Viking Age to Medieval date, together with House 19 and possibly House 10 on Terrace III and House 18 on the intervening area.
